INSPECTION REPORT R214

ISSUE DATE:	15 December 2023	CONFIDENTIALITY:	Confidential
SUBJECT:	RAAC Discovery Inspection		
PROJECT:	NHSScotland Assure RAAC Investigations	AUTHOR:	#024
CHECKED:	#012	APPROVED:	#002

NHS Board:	Forth Valley	
Site Code:	V201H	
Site Name:	Stirling Community Hospital	
Block No.:	21	
Block Name:	Estates	
Inspection Date:	06/11/2023	
Structural Engineers	#012	#024
NHS Estates	Jamie Hill	
Summary Status	RAAC not observed	No Action
Comments	No RAAC was observed within this building and therefore no related action is currently required.

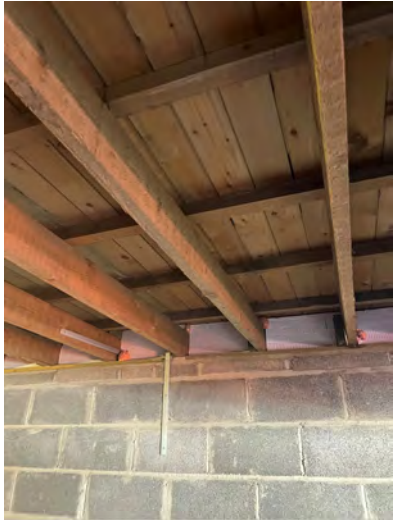
Location	Comments	Image		
01	<table border="1"> <tr> <td>RAAC not observed</td> <td>No action</td> </tr> </table> <p>Exposed timber flat roof joists, battens, and sarking above garage/stores.</p>	RAAC not observed	No action

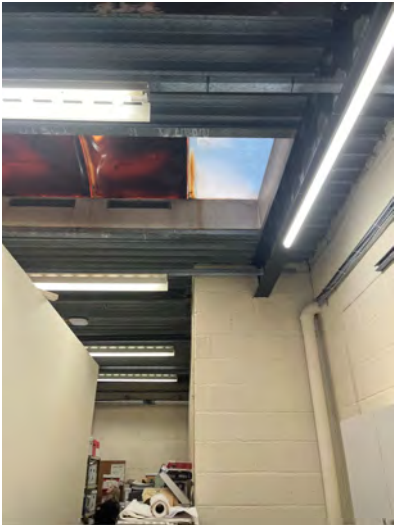
RAAC not observed	No action			
02	<table border="1"> <tr> <td>RAAC not observed</td> <td>No action</td> </tr> </table> <p>Underside of steel deck roof fixed to castellated steel beams above electrical stores. Walls are concrete blockwork walls.</p>	RAAC not observed	No action

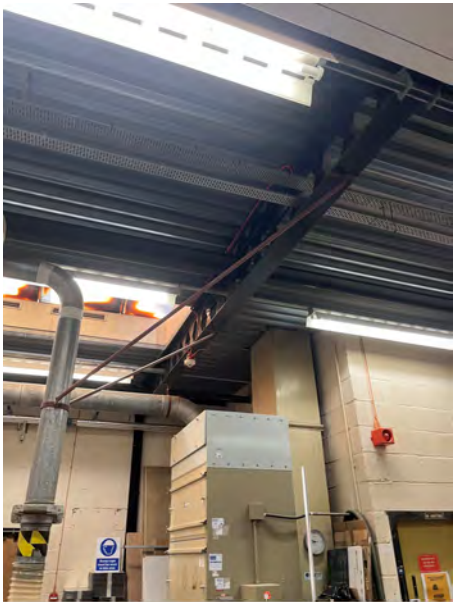
Location	Comment	Image		
03	<table border="1"> <tr> <td>RAAC not observed</td> <td>No action</td> </tr> </table> <p>Underside of steel deck roof with castellated support beams above joiner's workshop.</p> <p>Structure is like location 02.</p>	RAAC not observed	No action

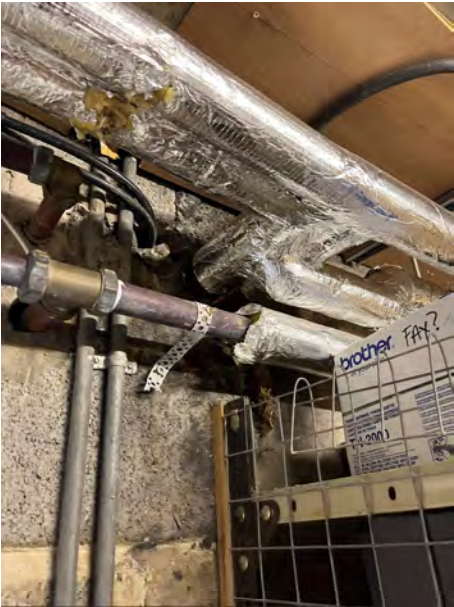
RAAC not observed	No action			
04	<table border="1"> <tr> <td>RAAC not observed</td> <td>No action</td> </tr> </table> <p>Assumed timber roof deck above estates office area (surrounding/adjointing areas determined to be of timber construction).</p>	RAAC not observed	No action

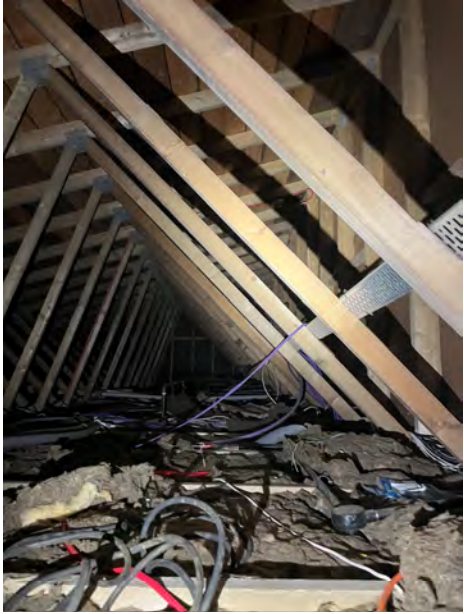
Location	Comment	Image		
05	<table border="1"> <tr> <td>RAAC not observed</td> <td>No action</td> </tr> </table> <p>Timber roof trusses supporting tiled, pitched roof above estates offices.</p>	RAAC not observed	No action

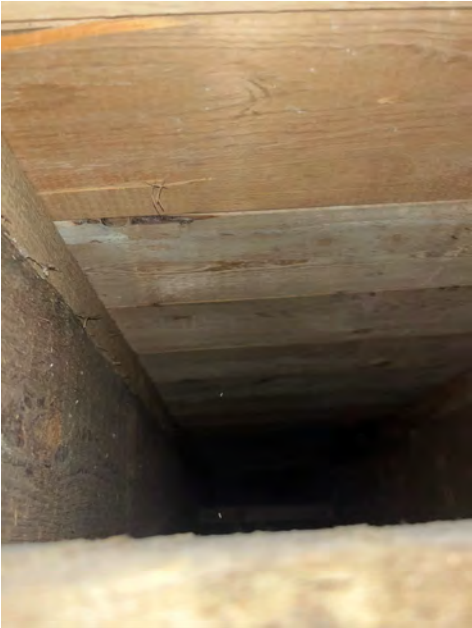
RAAC not observed	No action			
06	<table border="1"> <tr> <td>RAAC not observed</td> <td>No action</td> </tr> </table> <p>Timber flat roof (joists and sarking) above estates office block.</p>	RAAC not observed	No action

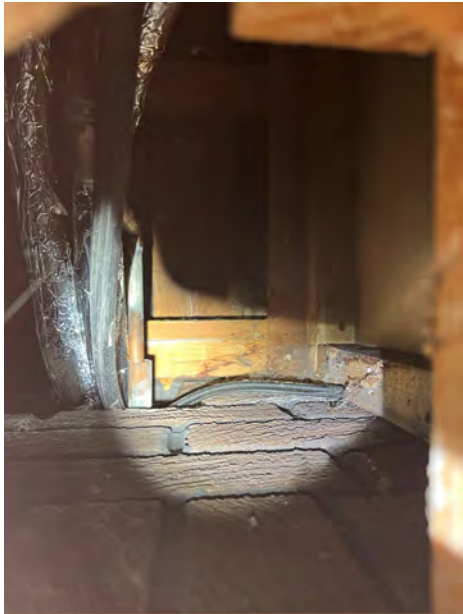
Location	Comment	Image		
07	<table border="1"> <tr> <td>RAAC not observed</td> <td>No action</td> </tr> </table> <p>Timber roof structure, visible through small opening in ceiling at main entrance of estates offices.</p>	RAAC not observed	No action

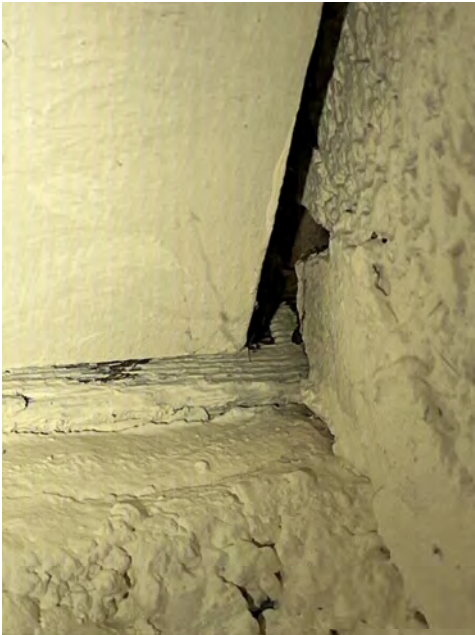
RAAC not observed	No action			
08	<table border="1"> <tr> <td>RAAC not observed</td> <td>No action</td> </tr> </table> <p>Assumed timber roof structure above wet store. Ceiling was deemed to be at risk of containing asbestos, but timber components could be seen through small gaps in the fabric. The adjacent roofs were determined to be a mix of timber and steel construction.</p> <p>Therefore, it is likely that this building will be of similar construction type as it appears to be built at a similar time based on similarities of the façade/</p>	RAAC not observed	No action

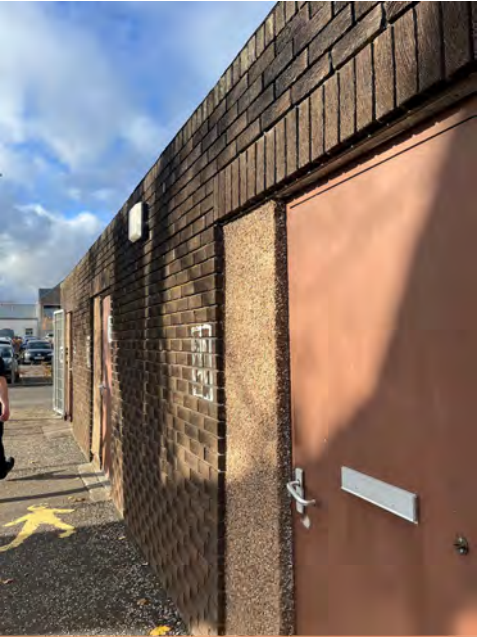
Location	Comment	Image		
External facade	<table border="1" data-bbox="304 694 852 757"> <tr> <td data-bbox="304 694 579 757">RAAC not observed</td> <td data-bbox="582 694 852 757">No action</td> </tr> </table> <p data-bbox="304 761 852 1357">This image is representative of the external façade, showing brick cavity walls supporting timber flat roofs with bituminous felt coverings.</p>	RAAC not observed	No action
