# INSPECTION REPORT R215

<b>ISSUE DATE:</b>	15 December 2023	<b>CONFIDENTIALITY:</b>	Confidential
<b>SUBJECT:</b>	RAAC Discovery Inspection		
<b>PROJECT:</b>	NHSScotland Assure RAAC Investigations	<b>AUTHOR:</b>	#024
<b>CHECKED:</b>	#012	<b>APPROVED:</b>	#002

<b>NHS Board:</b>	Forth Valley	
<b>Site Code:</b>	V201H	
<b>Site Name:</b>	Stirling Community Hospital	
<b>Block No.:</b>	06	
<b>Block Name:</b>	Rehabilitation/Ward 9	
<b>Inspection Date:</b>	06/11/2023	
<b>Structural Engineers</b>	#012	#024
<b>NHS Estates</b>	Jamie Hill	
<b>Summary Status</b>	RAAC not observed	No Action
<b>Comments</b>	No RAAC was observed within this building and therefore no related action is currently required.

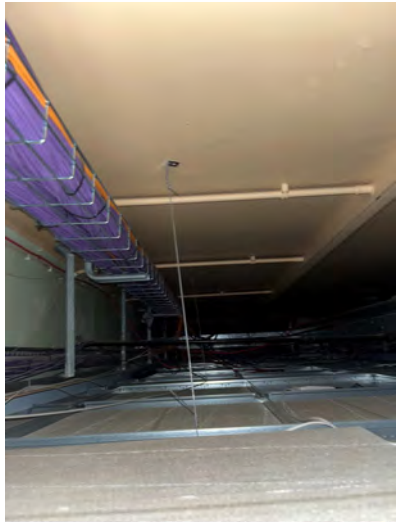
Location	Comments	Image		
01	<table border="1"> <tr> <td>RAAC not observed</td> <td>No action</td> </tr> </table> <p>Photo taken above the suspended ceiling on the ground floor. Original ceiling is of lath and plaster, which is fixed to the concrete supporting the floor above.</p>	RAAC not observed	No action

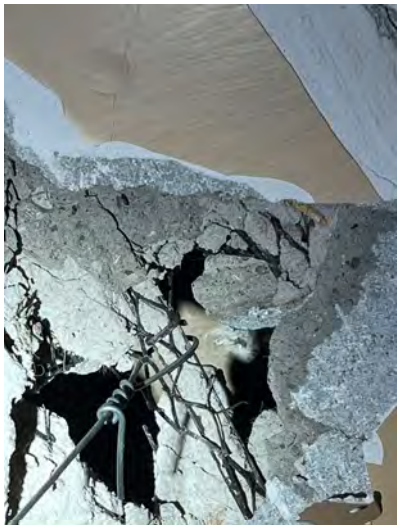
RAAC not observed	No action			
02	<table border="1"> <tr> <td>RAAC not observed</td> <td>No action</td> </tr> </table> <p>Solid concrete flat roof deck could be seen via damage to the lath and plaster finish of the ground floor ceiling.</p>	RAAC not observed	No action

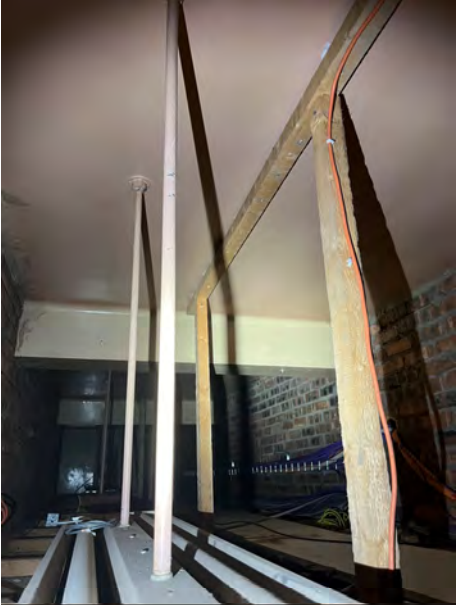
Location	Comment	Image		
03	<table border="1"> <tr> <td>RAAC not observed</td> <td>No action</td> </tr> </table> <p>Photo taken within the ground floor ceiling void showing original lath and plaster finish, which is fixed to the underside of the (assumed) concrete flat roof deck. Note: The (assumed) concrete support beams could also be seen.</p> <p>Internal brickwork walls were also visible.</p>	RAAC not observed	No action

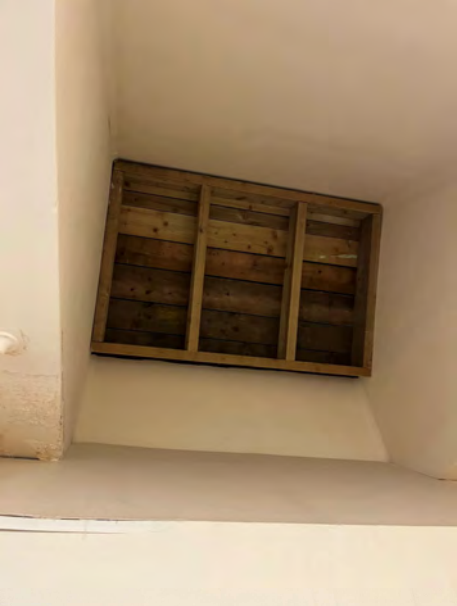
RAAC not observed	No action			
04	<table border="1"> <tr> <td>RAAC not observed</td> <td>No action</td> </tr> </table> <p>Photo taken on the first floor showing the exposed underside of the timber pitched roof.</p>	RAAC not observed	No action

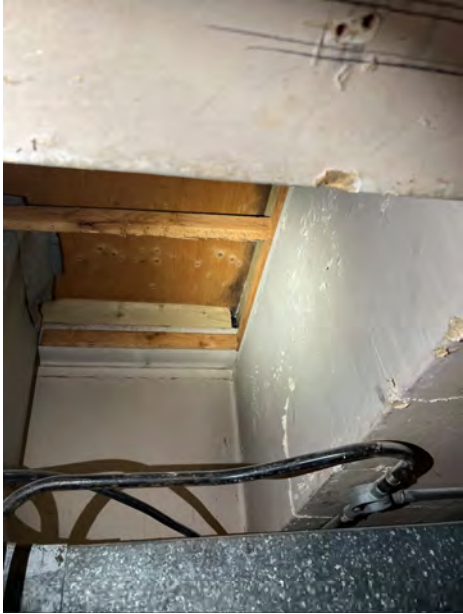
Location	Comment	Image		
05	<table border="1"> <tr> <td>RAAC not observed</td> <td>No action</td> </tr> </table> <p>Rooflight opening in concrete flat roof has been boarded over with timber.</p>	RAAC not observed	No action

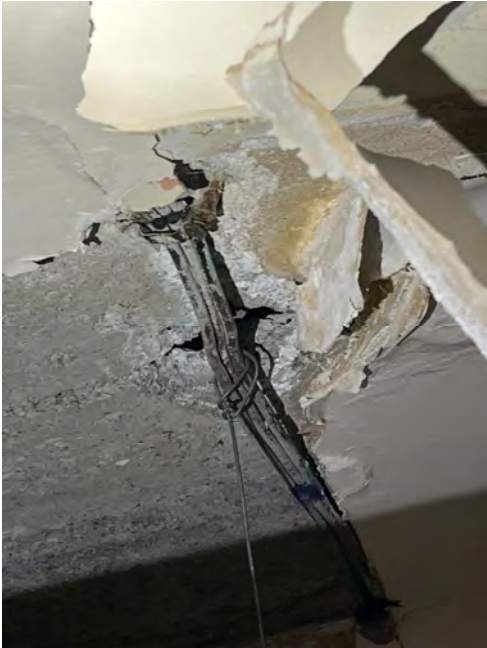
RAAC not observed	No action			
06	<table border="1"> <tr> <td>RAAC not observed</td> <td>No action</td> </tr> </table> <p>Photo taken above the suspended ceiling in the female changing room, showing damage to the original plaster which has exposed the underside of the concrete flat roof deck.</p> <p>Concrete was solid and dense when tapping with a screwdriver.</p>	RAAC not observed	No action

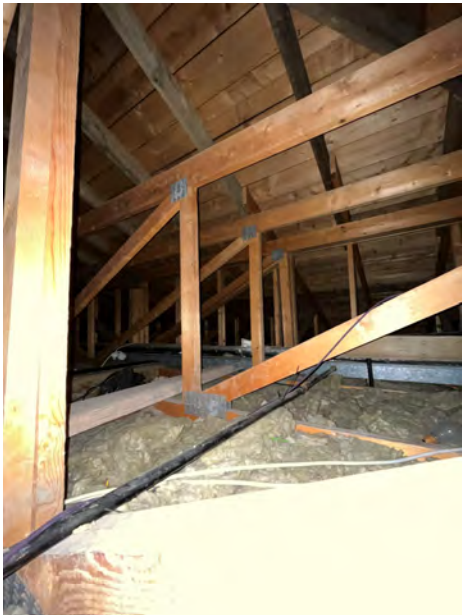
Location	Comment	Image		
07	<table border="1"> <tr> <td>RAAC not observed</td> <td>No action</td> </tr> </table> <p>Timber pitched roof components. Photo taken via loft access hatch.</p>	RAAC not observed	No action

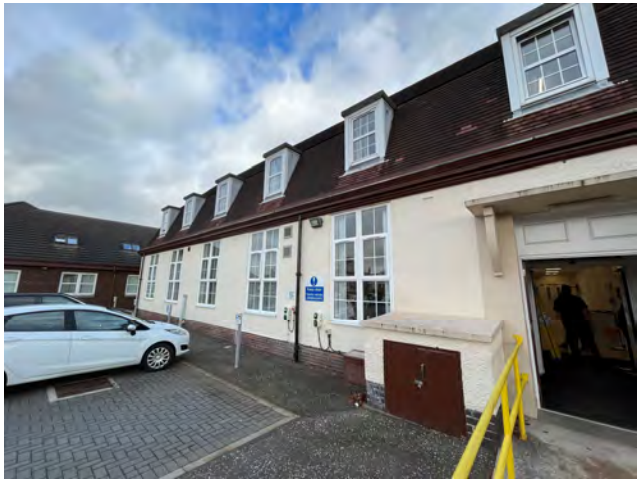
RAAC not observed	No action			
External facade	<table border="1"> <tr> <td>RAAC not observed</td> <td>No action</td> </tr> </table> <p>This image is representative of the external façade, showing rendered brick walls and tile-covered pitched roofs. To the rear of the property, adjoining the rest of the hospital, is a single storey structure with concrete flat roof.</p>	RAAC not observed	No action
