# INSPECTION REPORT R216

<b>ISSUE DATE:</b>	15 December 2023	<b>CONFIDENTIALITY:</b>	Confidential
<b>SUBJECT:</b>	RAAC Discovery Inspection		
<b>PROJECT:</b>	NHSScotland Assure RAAC Investigations	<b>AUTHOR:</b>	#012
<b>CHECKED:</b>	#002	<b>APPROVED:</b>	#002

<b>NHS Board:</b>	Forth Valley	
<b>Site Code:</b>	V214B	
<b>Site Name:</b>	Bannockburn Health Centre	
<b>Block No.:</b>	01	
<b>Block Name:</b>	Bannockburn Health Centre	
<b>Inspection Date:</b>	06/11/2023	
<b>Structural Engineers</b>	WSP Engineer #012	
<b>NHS Estates</b>	Jamie Hill	
<b>Summary Status</b>	RAAC not observed	No Action

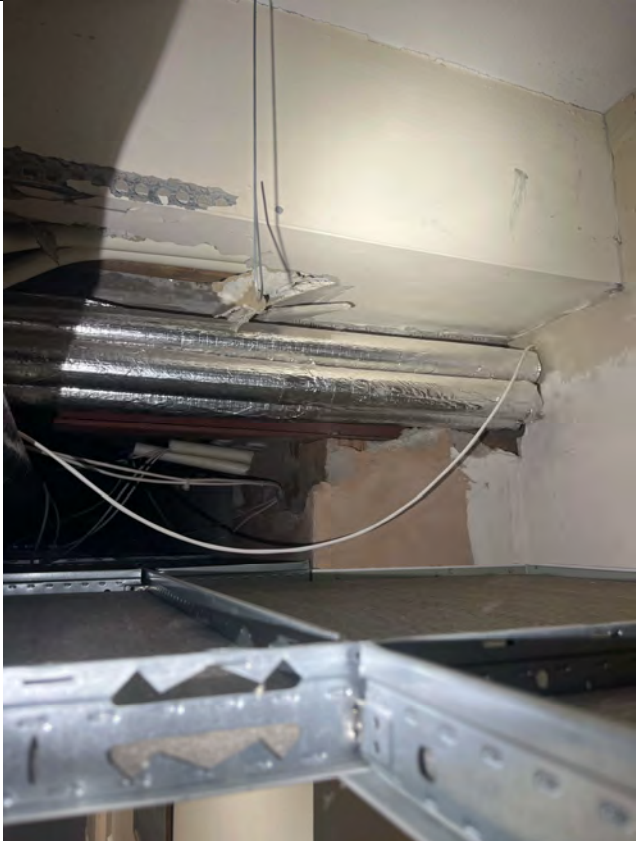
Location	Comments	Images		
01	<table border="1"> <tr> <td>RAAC not observed</td> <td>No action</td> </tr> </table> <p>The structure at location 01 was hidden by fixed plasterboard ceiling for the monopitched roof section roof above. It is anticipated that the monopitched roof it timber rafters based on evidence at location 05.</p> <p>The flat roof portion is concrete beam and block infill. This can be seen more clearly at location 02 &amp; 03 along the corridor.</p> <p>The rooms either side of the corridor at location 01 had fixed plasterboard ceiling so the structure could not be viewed.</p>	RAAC not observed	No action

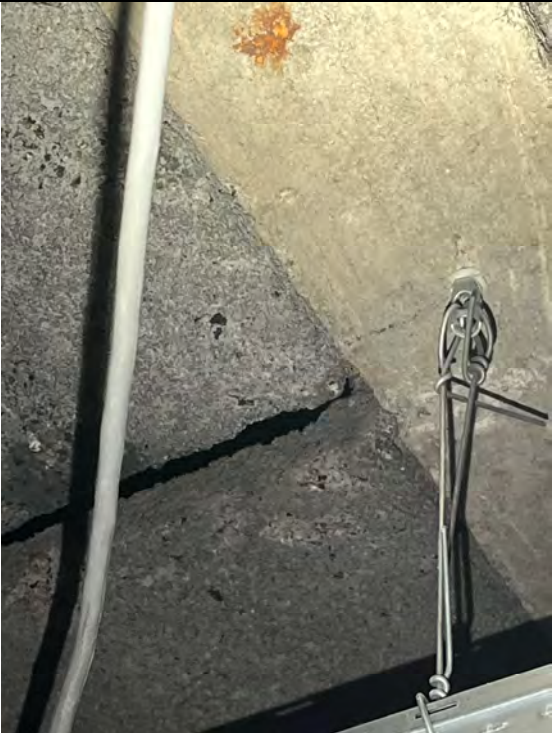
03	RAAC not observed	No action
	<p>The structure at location 03 is like location 02. This photo is where the blocks appeared to be hollow dense concrete blocks.</p>

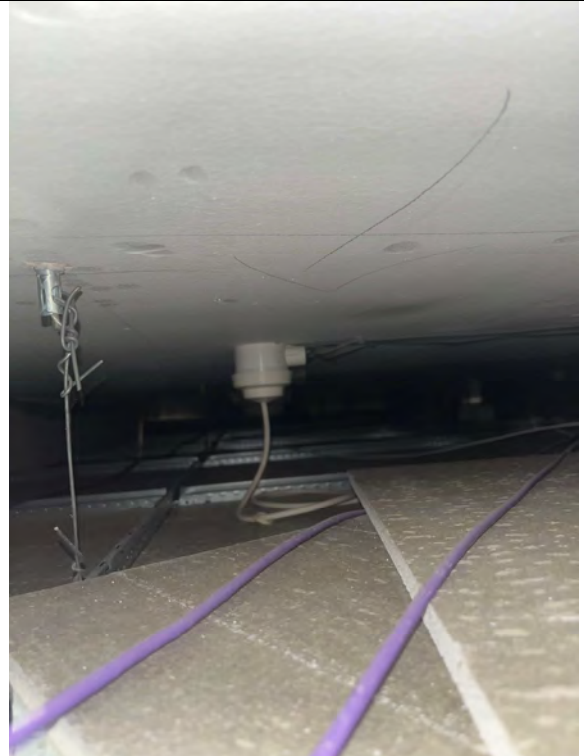
04	RAAC not observed	No action
	<p>The structure at location 04 above the suspended ceiling had a painted finish. Joints were not visible at this location and the underside was solid when tapping. The underside of the stairway towards the back appeared to be reinforced concrete. As this forms the structure for the floor above it is likely that this is reinforced concrete slab or beam and block similar to location 02 &amp; 03.</p>

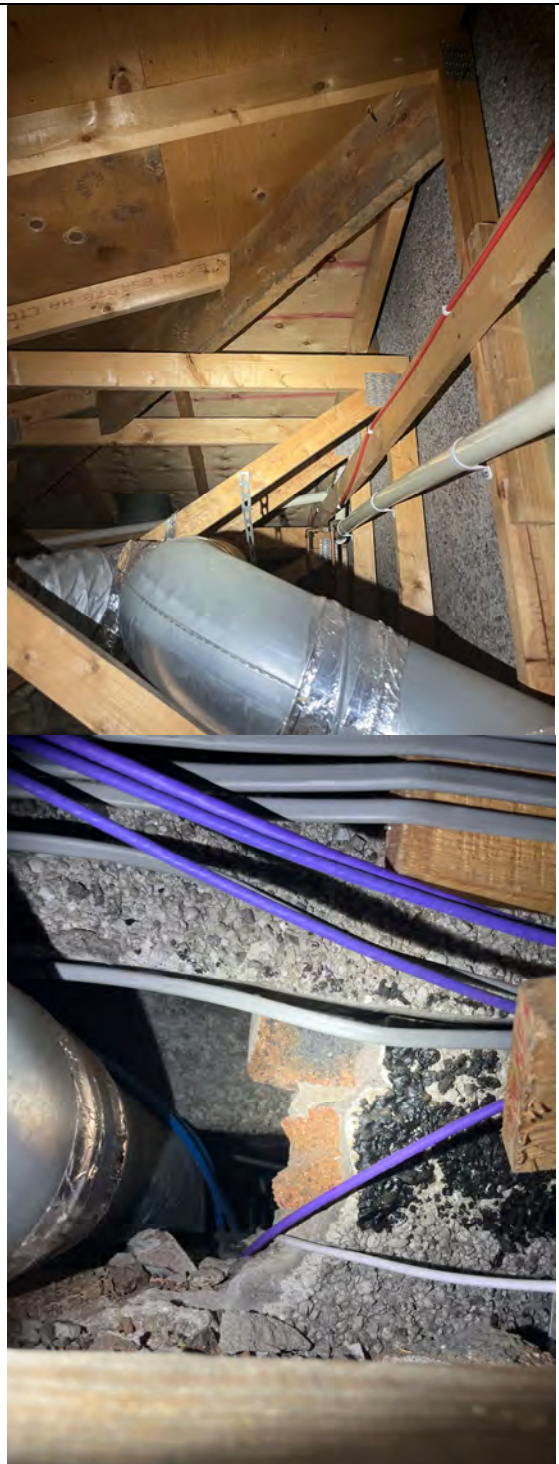
05

The roof structure for the monopitched roof section of the health centre is a monopitched timber truss with plywood timber sarking. This appears to be an extension as it abuts the pebbledash rendered exterior of the health centre. Furthermore, a penetration in the wall showed the cavity wall with a brick masonry outer leaf and a concrete block inner leaf.

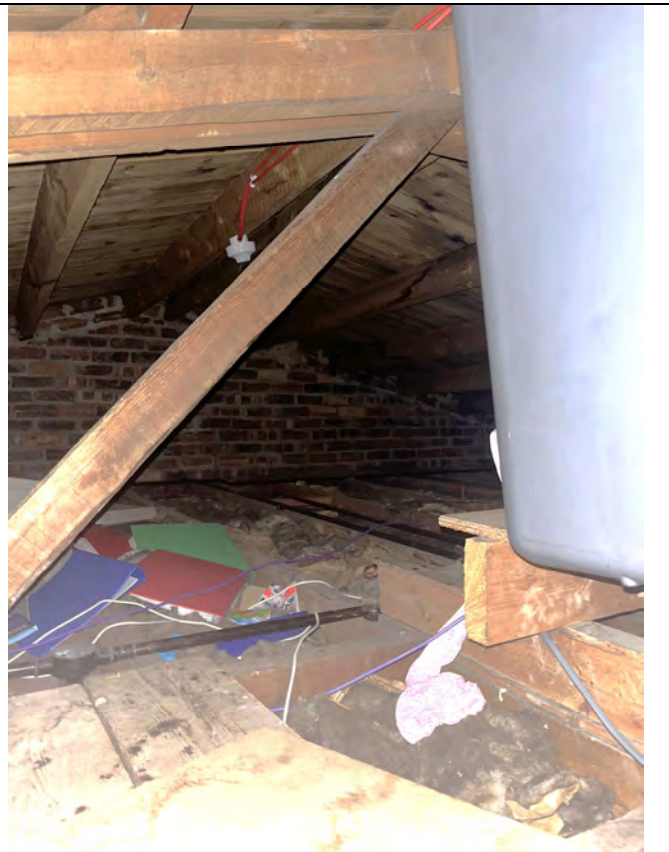
06 (First Floor)	RAAC not observed	No action
	<p>The structure in the first-floor roof level is a duo-pitched timber truss with plywood sarking. The gable walls are loadbearing brick masonry. Timber joists support the ceiling below.</p>

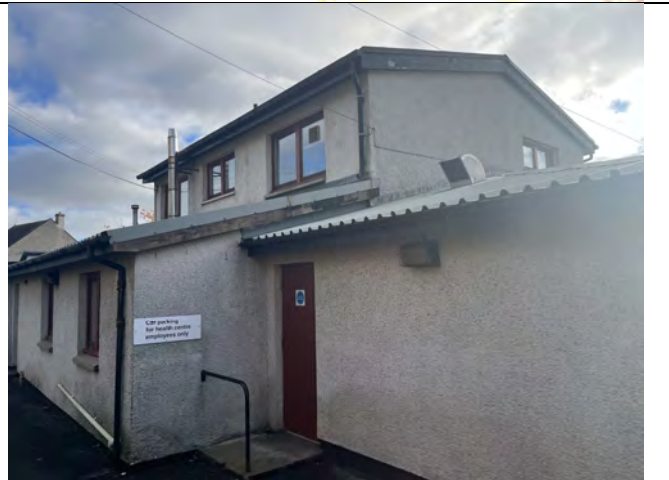
External Facade	RAAC not observed	No action
	<p>The external façade is a masonry cavity wall with roughcast render.</p>
