# INSPECTION REPORT R217

<b>ISSUE DATE:</b>	15 December 2023	<b>CONFIDENTIALITY:</b>	Confidential
<b>SUBJECT:</b>	RAAC Discovery Inspection		
<b>PROJECT:</b>	NHS Scotland Assure RAAC Investigations	<b>AUTHOR:</b>	#011
<b>CHECKED:</b>	#003	<b>APPROVED:</b>	#002

<b>NHS Board:</b>	Forth Valley	
<b>Site Code:</b>	V105B	
<b>Site Name:</b>	Bo'ness Health Centre	
<b>Block No.:</b>	02	
<b>Block Name:</b>	Bo'ness Health Centre	
<b>Inspection Date:</b>	07/11/2023	
<b>Structural Engineers</b>	#011	
<b>NHS Estates</b>	Jamie Hill	
<b>Summary Status</b>	<b>RAAC observed</b>	<b>Annual Inspection</b>
<b>Comments</b>	Planks are generally in good condition, but to align with current guidance investigation of bearings is recommended.

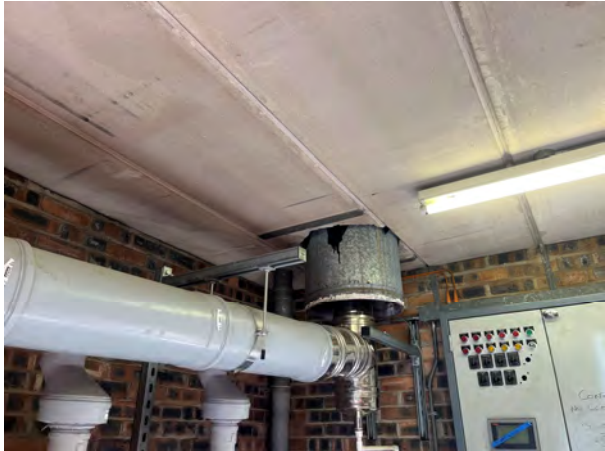
Location	Comment	Image
03	<p><b>RAAC observed</b> Annual Inspection</p> <p>The plantroom at the end of the building comprised brick masonry walls supporting a RAAC plank roof structure. Some discolouring was noted to the surface however this was believed to be related to installation. Some longitudinal cracks were noted within the plank junctions, but no cracks were noted within the planks themselves. There was no evidence of water ingress or staining. A service penetration was noted within the corner of the room, this had been trimmed with trimming steel typical for this type of construction, <u>however it is not clear how some of the residual RAAC around the penetration is supported. This ought to be investigated further.</u></p> <p>The width of bearings and internal reinforcement at the support could not be measured.</p>

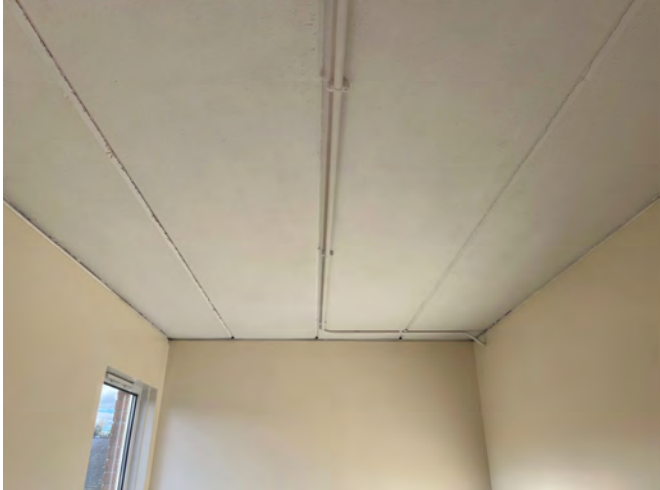
04	<p><b>RAAC observed</b> Triennial Inspection</p> <p>Stairwell between the upper and lower floors had RAAC panels forming the roof structure. These spanned from the stairwell walls which were lined, but sounded solid when tapped. There was evidence of cracks between the planks but none to the planks themselves. There was no clear evidence of water ingress or notable deflection.</p> <p>The width of bearings and internal reinforcement at the support could not be measured.</p>

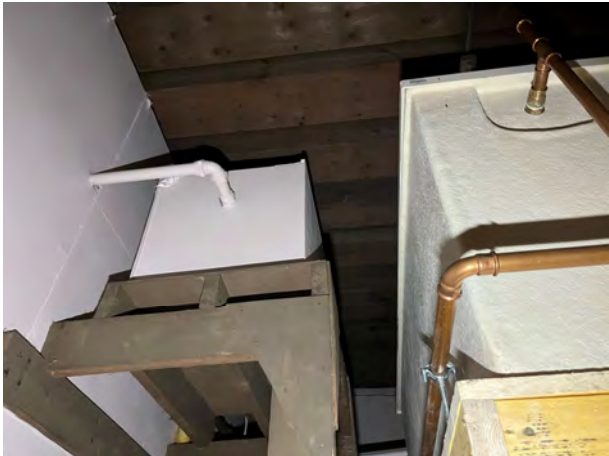
Location	Comment	Image
05	<div style="display: flex; justify-content: space-between;"> <div style="background-color: #90EE90; padding: 2px;">RAAC not observed</div> <div style="background-color: #00BFFF; padding: 2px;">No action</div> </div> <p>A loft hatch on the first floor provided access to the roof projection which housed water tanks. This observation point revealed a timber roof structure spanning over lined walls. The floor slab was reinforced concrete.</p>

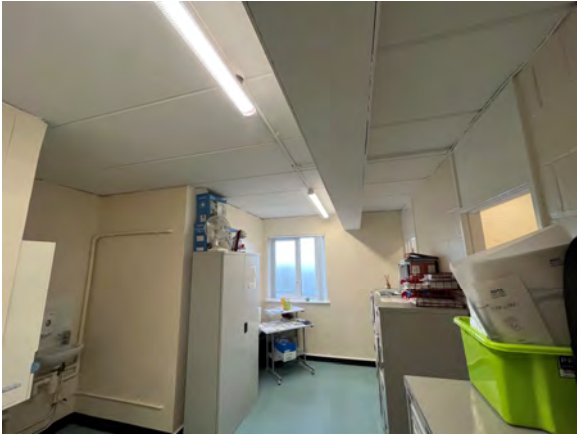
08 (representative of first floor roof structure, locations 06-09)	<div style="display: flex; justify-content: space-between;"> <div style="background-color: #FF0000; color: white; padding: 2px;">RAAC observed</div> <div style="background-color: #90EE90; padding: 2px;">Triennial Inspection</div> </div> <p>RAAC planks were observed throughout the first floor. These generally spanned between boxed down-stand beams which are believed to be hot rolled steel sections based on observations elsewhere in the building. The boxing was circa 320mm deep by 280mm wide. Blockwork and brickwork walls extended to the underside of the planks, however it is believed the planks span between the perimeter walls and down-stands. Maximum span measured was 5.15m. The perimeter walls were lined, and the brickwork bonding could not be observed. No clear evidence of distress, water ingress or notable deflections were noted.</p> <p>The width of bearings and internal reinforcement at the support could not be measured.</p>

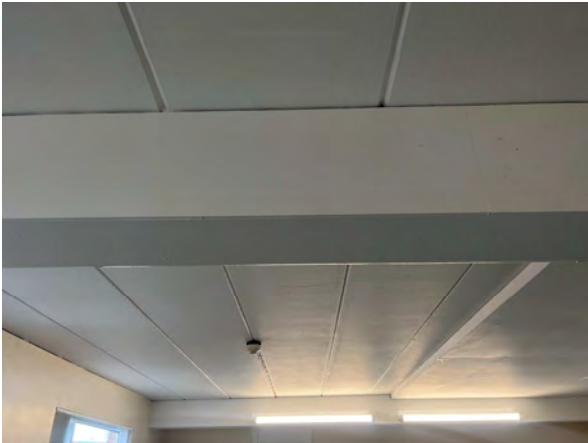
Location	Comment	Image
10	<p><b>RAAC observed</b>      Triennial Inspection</p> <p>RAAC roof panels and the concrete floor slab of the water tank projection were visible from the staff room on the first floor. Both elements spanned between down-stand beams, maximum span was measured as 5.05m. No clear evidence of distress, water ingress or notable deflections were noted.</p> <p>The width of bearings and internal reinforcement at the support could not be measured.</p>

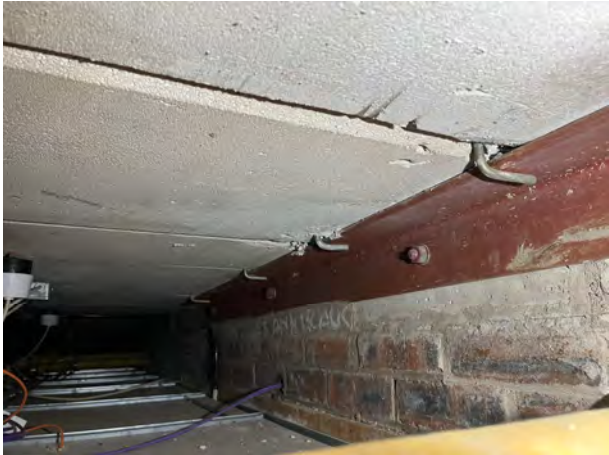
12 (representative of ground floor roof structure, locations 11-14)	<p><b>RAAC observed</b>      Triennial Inspection</p> <p>RAAC planks were observed throughout the ground floor ceiling space, except for the concrete floor slabs supporting the first-floor areas. Planks were generally supported by brickwork masonry walls or boxed, down-stand beams. Location 12 had an equal angle section bolted to the head of the wall to support the planks. This angle was present along the eastern end of the wall only. There was some distress noted to the surface of the planks in the form of spalling near the plank edges, this is believed to have been related to installation. No clear evidence of water ingress or notable deflections were noted.</p> <p>The width of bearings and internal reinforcement at the support could not be measured.</p>

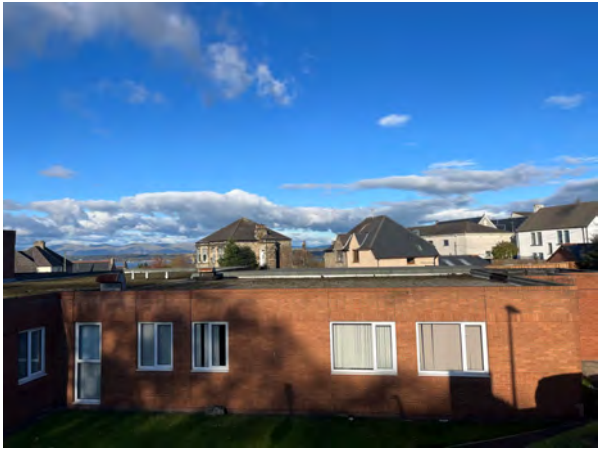
Location	Comment	Image
External facade	RAAC not observed

No action	
	The external façade comprised stretcher bond brick masonry, PVCu window joinery and a shallow fall roof with a gravel chip layer.
