# INSPECTION REPORT R218

<b>ISSUE DATE:</b>	15 December 2023	<b>CONFIDENTIALITY:</b>	Confidential
<b>SUBJECT:</b>	RAAC Discovery Inspection		
<b>PROJECT:</b>	NHSScotland Assure RAAC Investigations	<b>AUTHOR:</b>	#025
<b>CHECKED:</b>	#011	<b>APPROVED:</b>	#002

<b>NHS Board:</b>	Forth Valley	
<b>Site Code:</b>	V101B	
<b>Site Name:</b>	Grangemouth Health Centre	
<b>Block No.:</b>	01	
<b>Block Name:</b>	Grangemouth Health Centre	
<b>Inspection Date:</b>	07/11/2023	
<b>Structural Engineers</b>	WSP Engineer #011	
<b>NHS Estates</b>	Jamie Hill	
<b>Summary Status</b>	RAAC not observed	No RAAC Action
<b>Comments</b>	No RAAC was observed within this building, however some additional opening is recommended where noted.

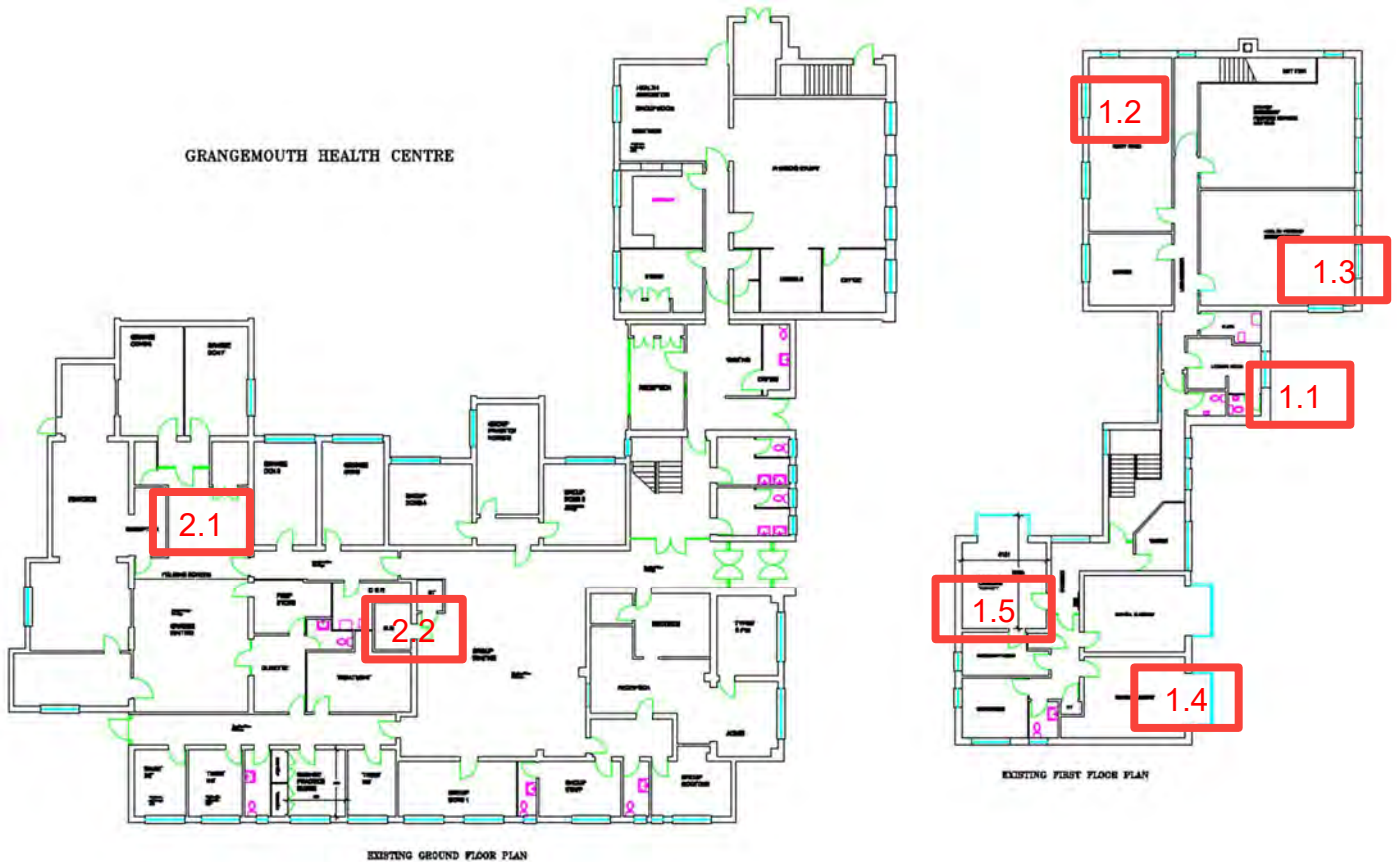
Figure 2 – Inspection plan

The floor plan below shows locations where the structure was observed from either the underside of the roof where it was exposed, or within the ceiling void. Only areas positively identified as being free from asbestos by the on-site asbestos surveyor were considered for inspection.

The locations viewed revealed the different forms of construction used within the building, it is reasonable to assume that the ground floor locations are representative of the structure, however we recommend some additional opening at the upper storeys.

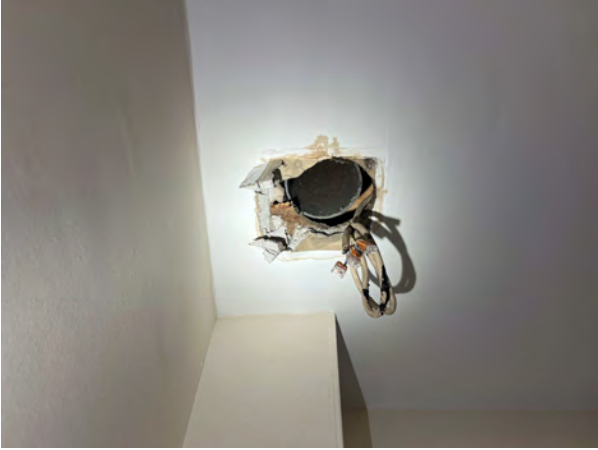
Location	Comments	Images		
1.1	<table border="1"> <tr> <td>RAAC not observed</td> <td>No action</td> </tr> </table> <p>Fixed ceiling within the central portion of the structure but flue penetration reveals OSB board above plasterboard ceiling finishes. Timber sarking was noted beyond, assumed to pass over timber roof rafters. However, these were not observed.</p>	RAAC not observed	No action

RAAC not observed	No action

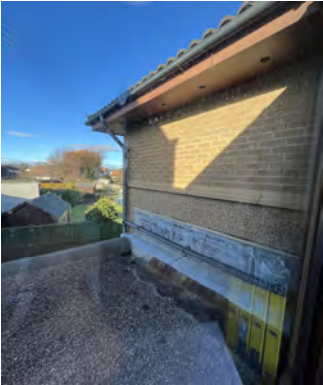
<p>1.2</p>	<p>A fixed ceiling throughout the northern building did not allow any inspections of the roof structure to be made. However, observations from the central corridor revealed a pitched tiled roof supported over brickwork walls. It is anticipated timber rafters or trusses would form the roof structure.</p>

The objective of our inspection was to determine whether RAAC is present within the building, however none was observed in the locations inspected. We are satisfied that the locations we viewed are representative of the construction on the single storey portion however we suggest hatches are provided in the northern and southern upper floor to confirm the roof construction in these locations.

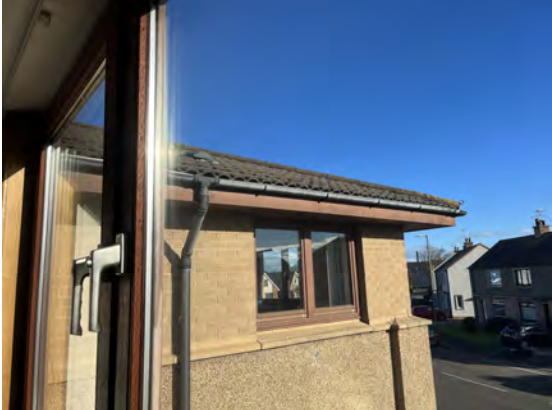
<p>1.3</p>	<p>As per 1.2.</p>

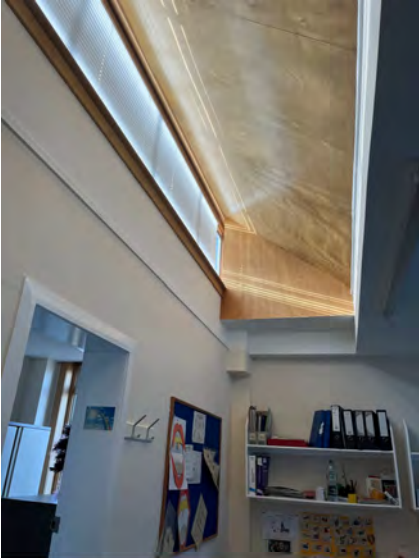
<p>1.4 and 1.5</p>	<p>Fixed ceilings throughout the southern portion of the building. The observation made at location 1.5 revealed a timber framed northlight/ clerestory structure. The external walls are lightweight metal and the internal wall structures sounded as stud walls. It is anticipated the roof structure is timber rafters supported off the stud walls.</p>

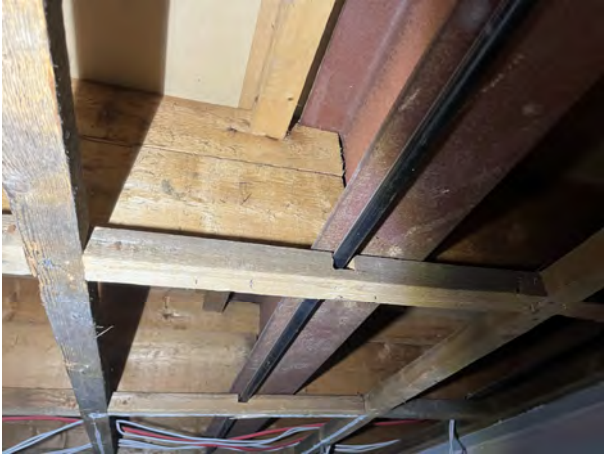
<p>2.1</p>	<p>RAAC not observed</p>	<p>No action</p>	<p>The single storey portion of the building was generally lined with fixed plasterboard ceilings throughout. However, a suspended ceiling portion at the waiting area allowed inspection of the roof space. This revealed steel down-stand beams supporting a timber roof structure. Load bearing walls were generally lined but limited observation points revealed these to be brickwork masonry walls.</p>

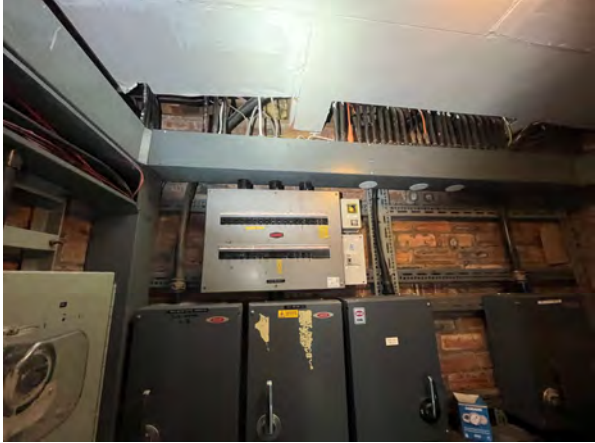
<p>2.2</p>	<p>RAAC not observed</p>	<p>No action</p>	<p>The distribution/plantroom revealed brickwork masonry walls throughout. A small section of ceiling had been removed and exposed a timber roof structure over.</p>

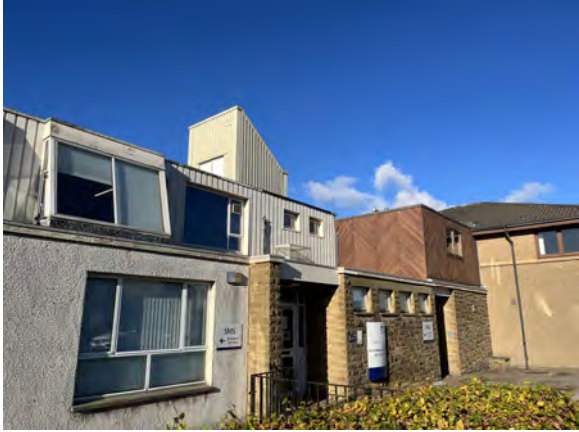
<p>External Facade</p>	<p>RAAC not observed</p>	<p>No action</p>	<p>As per the property description, the building comprises several forms of construction and cladding types, however none of the observations confirmed this to be RAAC.</p>
