INSPECTION REPORT R219

ISSUE DATE:	15 December 2023	CONFIDENTIALITY:	Confidential
SUBJECT:	RAAC Discovery Inspection		
PROJECT:	NHSScotland Assure RAAC Investigations	AUTHOR:	#025
CHECKED:	#011	APPROVED:	#002

NHS Board:	Forth Valley	
Site Code:	V109C	
Site Name:	Laurieston Health Centre	
Block No.:	01	
Block Name:	Laurieston Health Centre	
Inspection Date:	07/11/2023	
Structural Engineers	WSP Engineer #011	
NHS Estates	Jamie Hill	
Summary Status	RAAC not observed	No Action
Comments	No RAAC was observed within this building and therefore no related action is currently required.

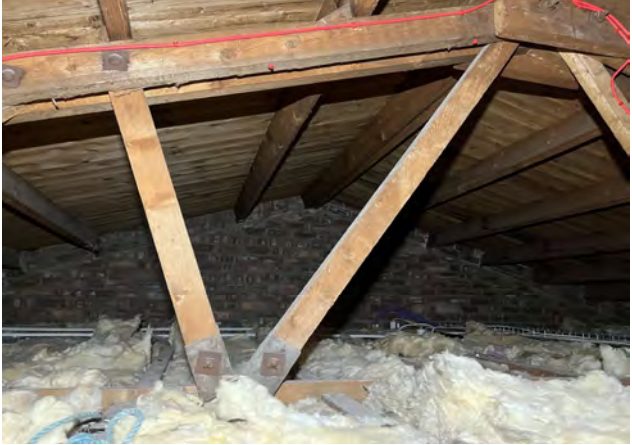
Location	Comments	Images		
01	<table border="1"> <tr> <td>RAAC not observed</td> <td>No action</td> </tr> </table> <p>Location 1 was a loft hatch in the fixed ceiling. The roof structure is a timber truss spanning to the external brick walls. Timber sarking is fixed to the purlins which span between the trusses.</p>	RAAC not observed	No action

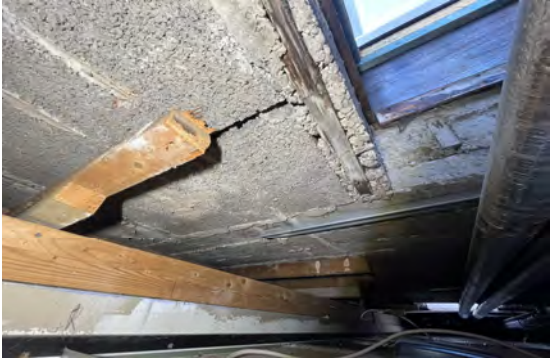
02	RAAC not observed	No action

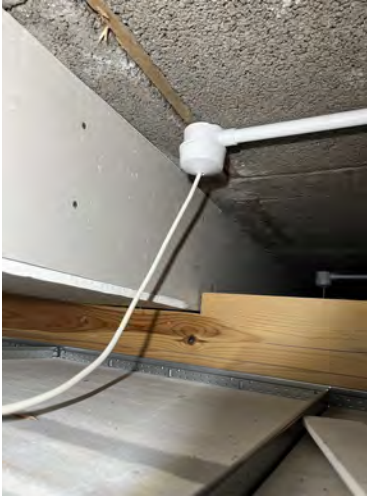
03	RAAC not observed	No action

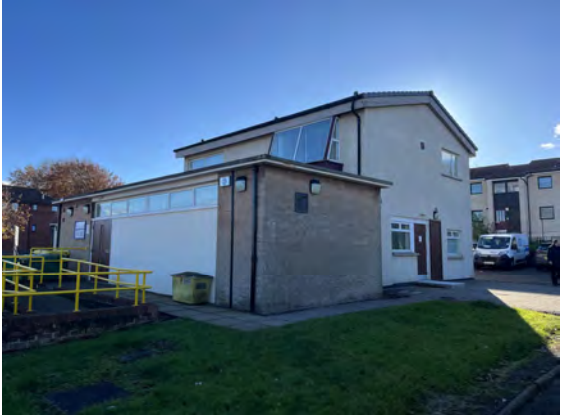
External Facade	RAAC not observed	No action
