SUBJECT: RAAC Discovery Inspection

PROJECT: NHSScotland Assure RAAC AUTHOR: #024

NHS Board:	Forth Valley		
Site Code:	V102H		
Site Name:	Falkirk Community Hospital		
Block No.:	39		
Block Name:	Ophthalmology		
Inspection Date:	07/11/2023		
Structural Engineers	#011	#024	
NHS Estates	Jamie Hill		
Summary Status	RAAC not observed	No Action	
Comments	No RAAC was observed within this building and therefore no		
	related action is currently required.

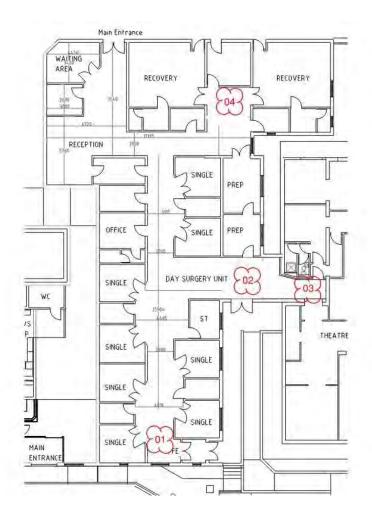
Figure 2 - Inspection plan

The floor plan below shows locations where the roof structure was observed from either the underside of the roof where it was exposed, or within the ceiling void. Only areas positively identified as being free from asbestos by the on-site asbestos surveyor were considered for inspection. In addition, several rooms were in use at the time of our visit and were therefore unavailable for inspection. That said, sufficient locations were viewed so that it is reasonable to assume that they are representative of the structure, and an accurate determination can be presented. We therefore do not foresee a need to view additional locations in the building for the purpose of RAAC Discovery.
