# INSPECTION REPORT R221

<b>ISSUE DATE:</b>	15 December 2023	<b>CONFIDENTIALITY:</b>	Confidential
<b>SUBJECT:</b>	RAAC Discovery Inspection		
<b>PROJECT:</b>	NHSScotland Assure RAAC Investigations	<b>AUTHOR:</b>	#024
<b>CHECKED:</b>	#011	<b>APPROVED:</b>	#002

<b>NHS Board:</b>	Forth Valley	
<b>Site Code:</b>	V102H	
<b>Site Name:</b>	Falkirk Community Hospital	
<b>Block No.:</b>	09	
<b>Block Name:</b>	Surgical	
<b>Inspection Date:</b>	07/11/2023	
<b>Structural Engineers</b>	#011	#024
<b>NHS Estates</b>	Jamie Hill	
<b>Summary Status</b>	RAAC not observed	No Action
<b>Comments</b>	No RAAC was observed within this building and therefore no related action is currently required.

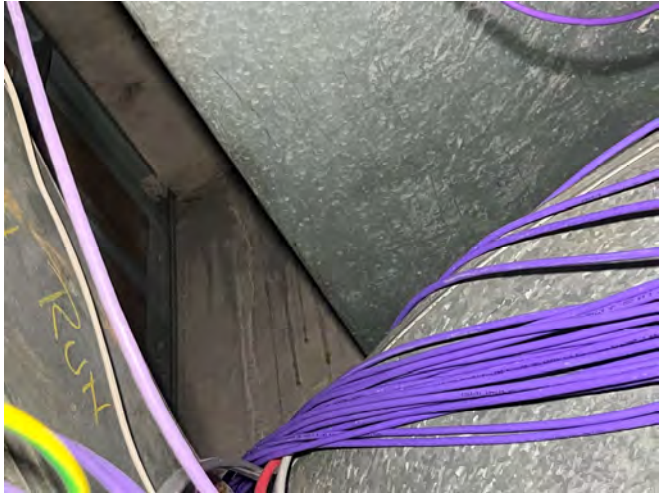
Location	Comments	Image		
01	<table border="1"> <tr> <td>RAAC not observed</td> <td>No action</td> </tr> </table> <p>Photo taken above ceiling tiles. View is partially obstructed by service infrastructure but reinforced concrete column can be seen. Concrete floor slab was observed, understood to form the roof plantroom projection.</p>	RAAC not observed	No action

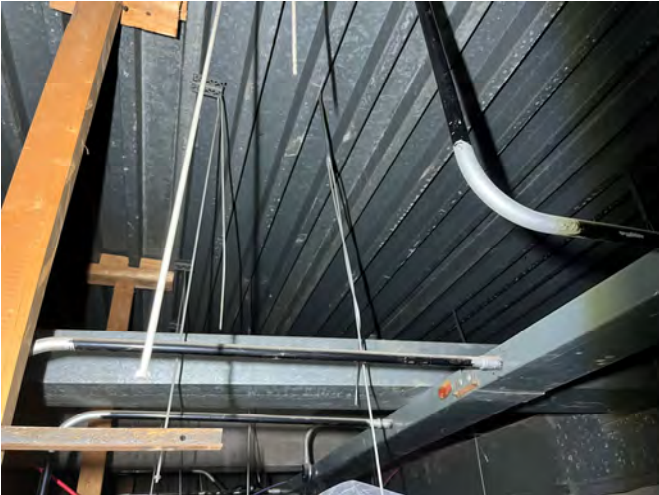
RAAC not observed	No action			
02	<table border="1"> <tr> <td>RAAC not observed</td> <td>No action</td> </tr> </table> <p>View within ceiling void on top floor of Surgical Block, showing underside of profile-steel sheet roofing system.</p>	RAAC not observed	No action

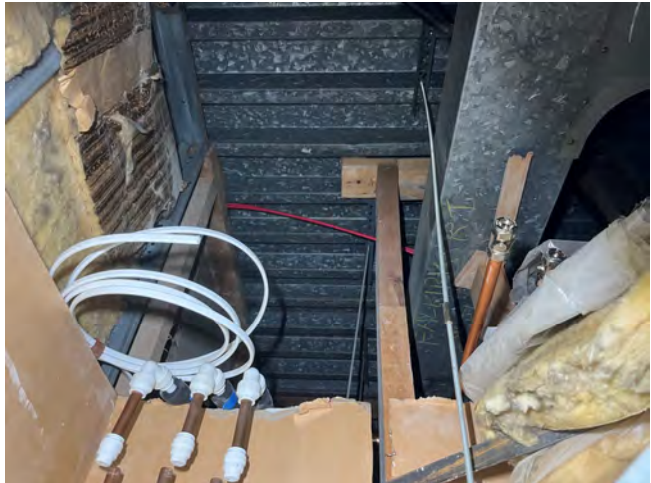
Location	Comment	Image		
03	<table border="1"> <tr> <td>RAAC not observed</td> <td>No action</td> </tr> </table> <p>Underside of profile metal roof. Photo taken within ceiling void above WC, at Northwest corner of Surgical Block.</p>	RAAC not observed	No action

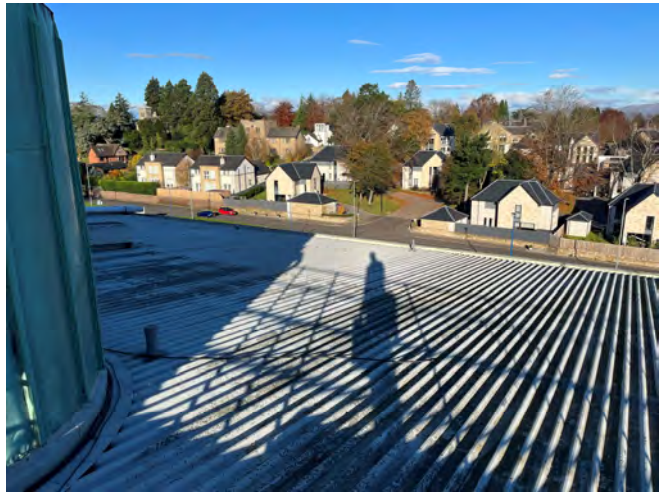
RAAC not observed	No action			
04	<table border="1"> <tr> <td>RAAC not observed</td> <td>No action</td> </tr> </table> <p>Photo taken from roof level gantry, east of the plant room projection, showing profile metal sheet roofing system.</p>	RAAC not observed	No action

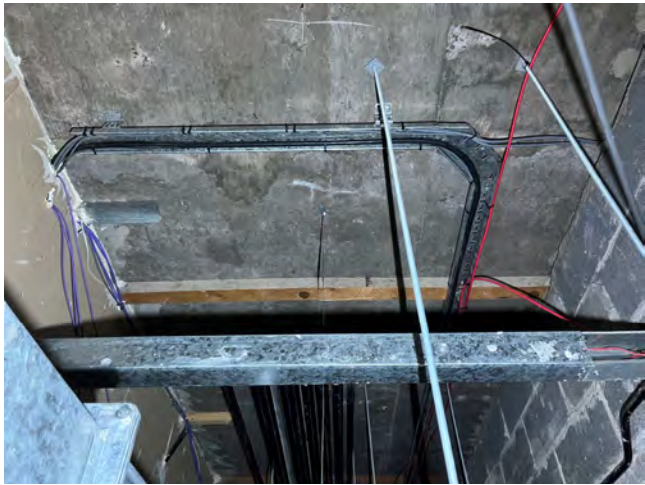
Location	Comment		Image
05	RAAC not observed	No action

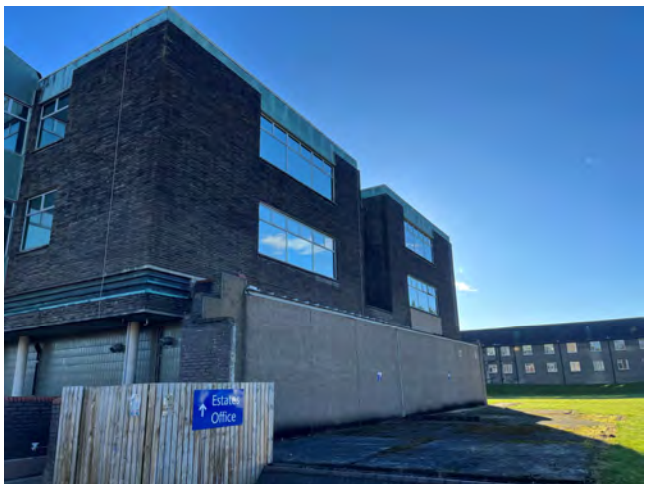
External facade	RAAC not observed	No action
