INSPECTION REPORT R214

ISSUE DATE:	15 December 2023	CONFIDENTIALITY:	Confidential
SUBJECT:	RAAC Discovery Inspection		
PROJECT:	NHSScotland Assure RAAC Investigations	AUTHOR:	#024
CHECKED:	#012	APPROVED:	#002

NHS Board:	Forth Valley	
Site Code:	V201H	
Site Name:	Stirling Community Hospital	
Block No.:	21	
Block Name:	Estates	
Inspection Date:	06/11/2023	
Structural Engineers	#012	#024
NHS Estates	Jamie Hill	
Summary Status	RAAC not observed	No Action
Comments	No RAAC was observed within this building and therefore no related action is currently required.

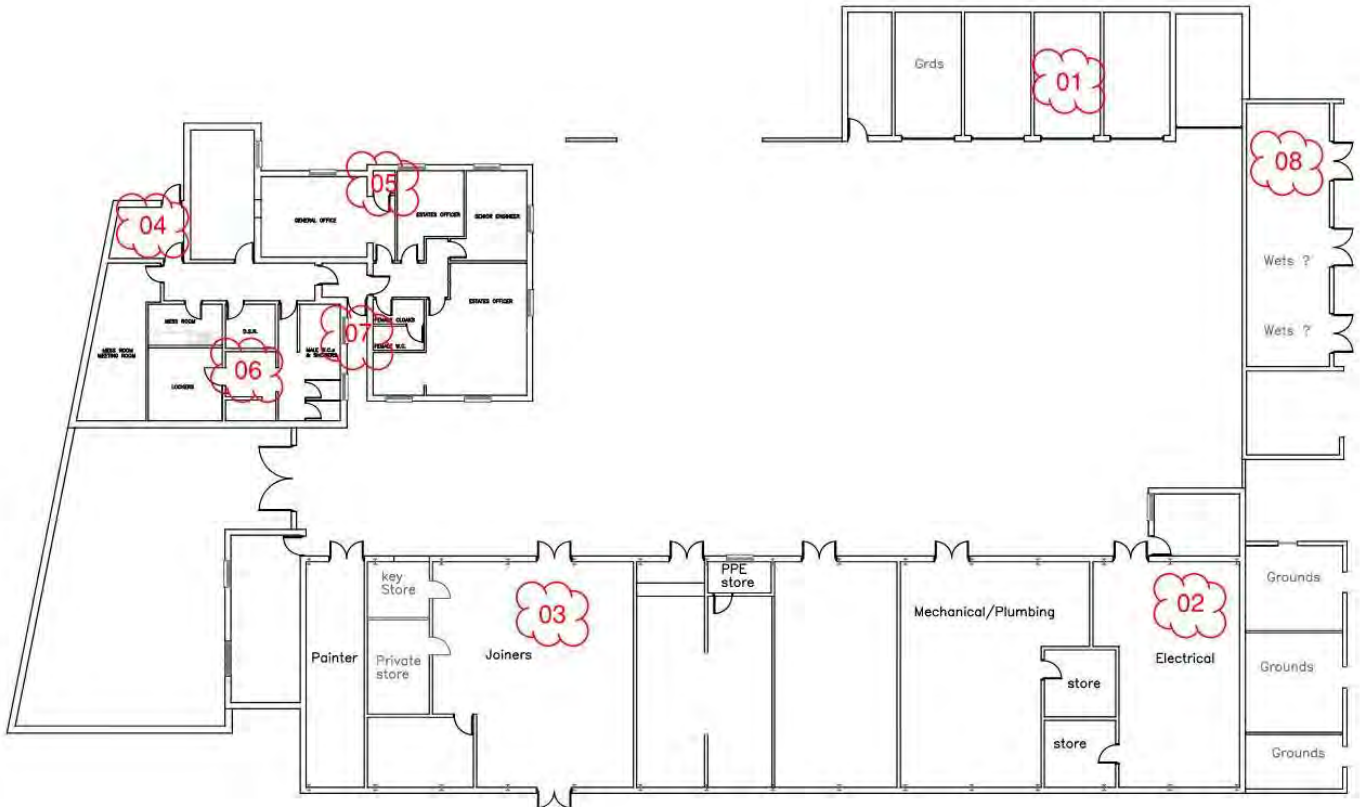
Figure 2: Inspection location plan

The floor plan below shows locations where the roof structure was observed from either the underside of the roof where it was exposed, or within the ceiling void. Only areas positively identified as being free from asbestos were considered for inspection. In addition, several rooms were in use at the time of our visit and were therefore unavailable for inspection. That said, sufficient locations were viewed so that it is reasonable to assume that they are representative of the structure, and an accurate determination can be presented. We therefore do not foresee a need to view additional locations in the building for the purpose of RAAC Discovery.
