# INSPECTION REPORT R216

<b>ISSUE DATE:</b>	15 December 2023	<b>CONFIDENTIALITY:</b>	Confidential
<b>SUBJECT:</b>	RAAC Discovery Inspection		
<b>PROJECT:</b>	NHSScotland Assure RAAC Investigations	<b>AUTHOR:</b>	#012
<b>CHECKED:</b>	#002	<b>APPROVED:</b>	#002

<b>NHS Board:</b>	Forth Valley	
<b>Site Code:</b>	V214B	
<b>Site Name:</b>	Bannockburn Health Centre	
<b>Block No.:</b>	01	
<b>Block Name:</b>	Bannockburn Health Centre	
<b>Inspection Date:</b>	06/11/2023	
<b>Structural Engineers</b>	WSP Engineer #012	
<b>NHS Estates</b>	Jamie Hill	
<b>Summary Status</b>	RAAC not observed	No Action

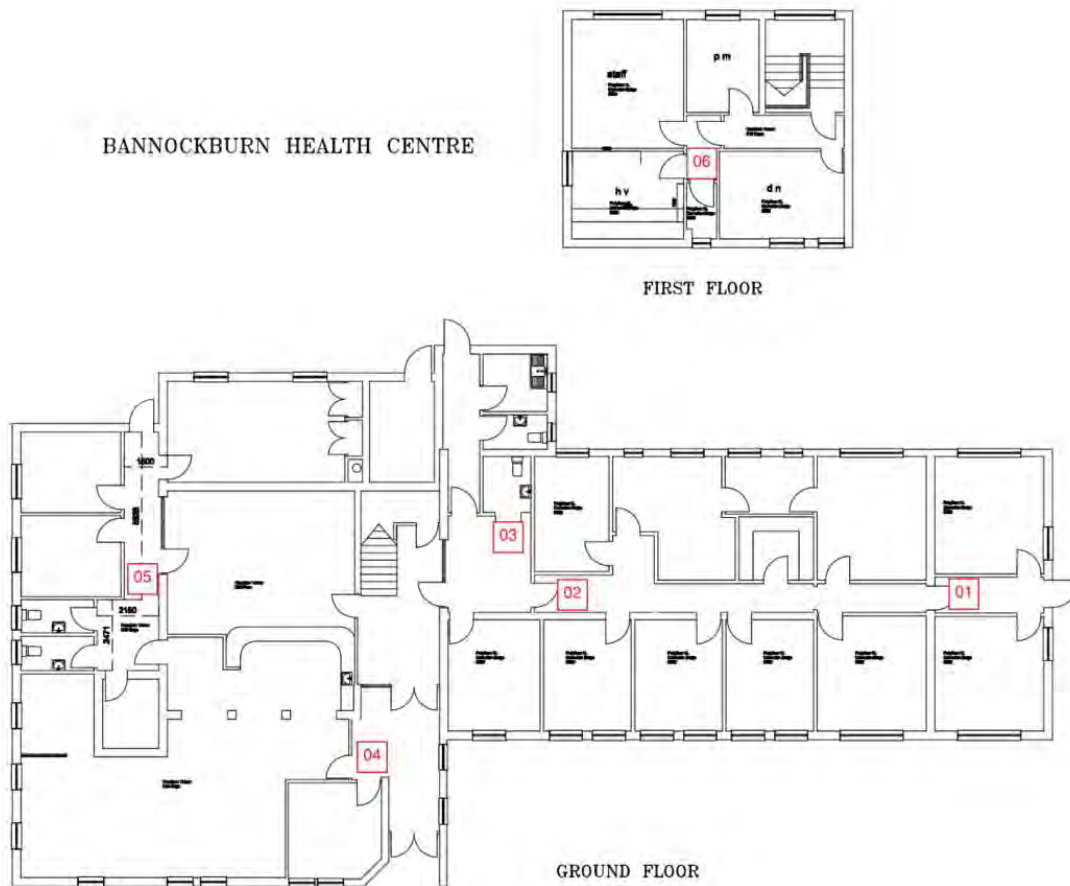
Figure 2 – Ground Floor Inspection plan

The floor plan below shows locations where the structure was observed. Only areas positively identified as being free from asbestos by the on-site asbestos surveyor were considered for inspection.
