INSPECTION REPORT R219

ISSUE DATE:	15 December 2023	CONFIDENTIALITY:	Confidential
SUBJECT:	RAAC Discovery Inspection		
PROJECT:	NHSScotland Assure RAAC Investigations	AUTHOR:	#025
CHECKED:	#011	APPROVED:	#002

NHS Board:	Forth Valley	
Site Code:	V109C	
Site Name:	Laurieston Health Centre	
Block No.:	01	
Block Name:	Laurieston Health Centre	
Inspection Date:	07/11/2023	
Structural Engineers	WSP Engineer #011	
NHS Estates	Jamie Hill	
Summary Status	RAAC not observed	No Action
Comments	No RAAC was observed within this building and therefore no related action is currently required.

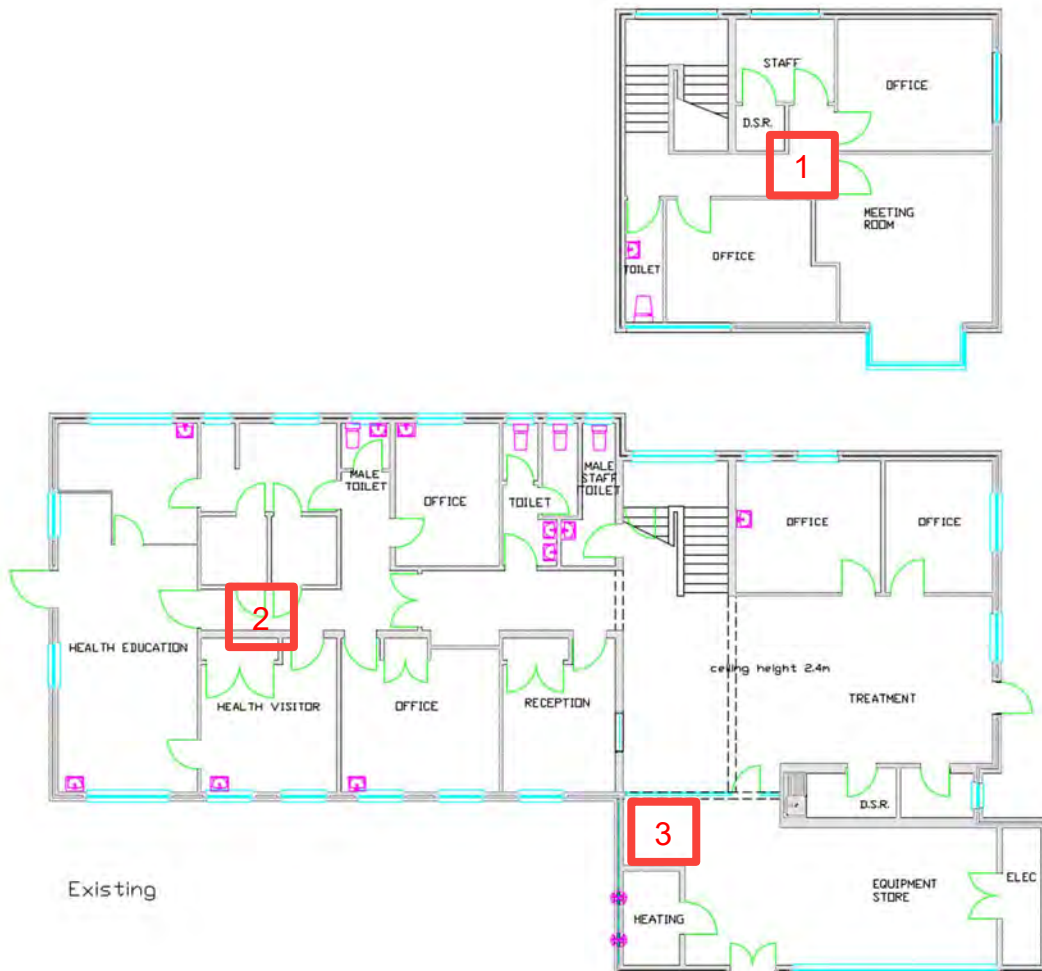
Figure 2 –Inspection plan

The floor plan below shows locations where the structure was observed from either the underside of the roof where it was exposed, or within the ceiling void. Only areas positively identified as being free from asbestos by the on-site asbestos surveyor were considered for inspection.

The locations viewed revealed the different forms of construction used within the building, it is reasonable to assume that they are representative of the structure. We do not foresee a need to view additional locations in the building for the purpose of RAAC Discovery.
