# INSPECTION REPORT R221

<b>ISSUE DATE:</b>	15 December 2023	<b>CONFIDENTIALITY:</b>	Confidential
<b>SUBJECT:</b>	RAAC Discovery Inspection		
<b>PROJECT:</b>	NHSScotland Assure RAAC Investigations	<b>AUTHOR:</b>	#024
<b>CHECKED:</b>	#011	<b>APPROVED:</b>	#002

<b>NHS Board:</b>	Forth Valley	
<b>Site Code:</b>	V102H	
<b>Site Name:</b>	Falkirk Community Hospital	
<b>Block No.:</b>	09	
<b>Block Name:</b>	Surgical	
<b>Inspection Date:</b>	07/11/2023	
<b>Structural Engineers</b>	#011	#024
<b>NHS Estates</b>	Jamie Hill	
<b>Summary Status</b>	RAAC not observed	No Action
<b>Comments</b>	No RAAC was observed within this building and therefore no related action is currently required.

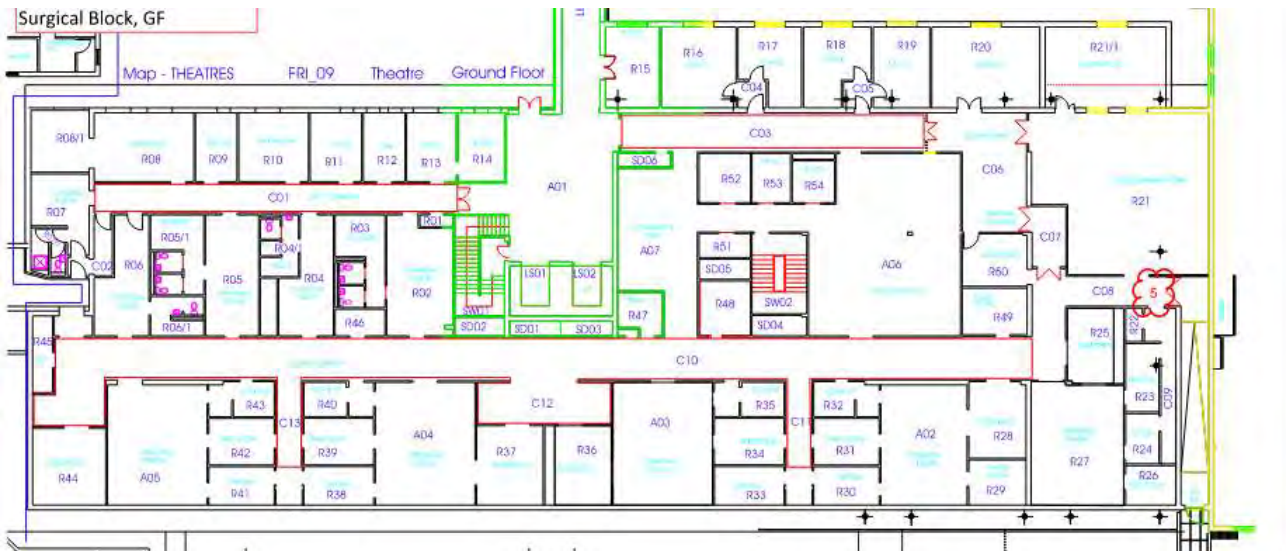
Figure 2 - Inspection plan, Ground Floor

The floor plan below shows locations where the roof structure was observed from either the underside of the roof where it was exposed, or within the ceiling void. Only areas positively identified as being free from asbestos were considered for inspection. In addition, several rooms were in use at the time of our visit and were therefore unavailable for inspection. That said, sufficient locations were viewed so that it is reasonable to assume that they are representative of the structure, and an accurate determination can be presented. We therefore do not foresee a need to view additional locations in the building for the purpose of RAAC Discovery.

Please Note: The photo numbered 4 was taken on the roof level and is not specifically shown on the plan below.
